CASE STUDY

Nansulate® Translucent PT

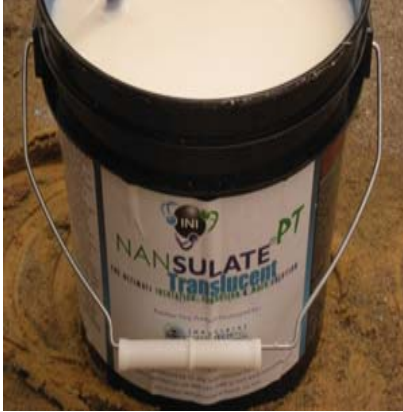
Above: Finished pipeline insulated with Nansulate® Translucent PT
Right: Technician applies coating with spray equipment in the field

Nansulate® Translucent PT was spray applied to a 24" dia. hot water pipeline to insulate and provide corrosion resistance. Thickness applied was 310 microns (apprx. 3 coats)

Temperature of pipeline surface before: 74 deg C.

Temperature of pipeline surface after: 59 deg. C.
